## MAIN CAMPUS

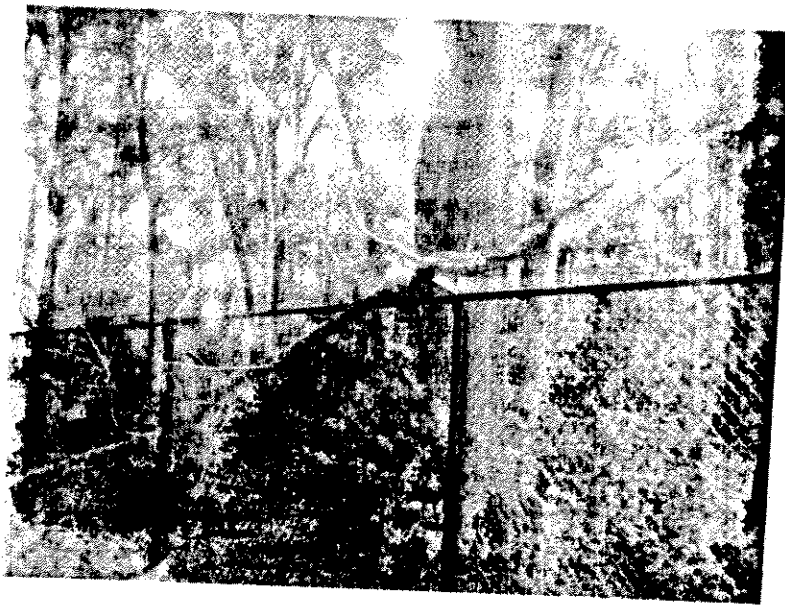
4

4. Barbed wire and support brackets damaged.
5. Overgrown vegetation.
6. Approximately 10" between the ground and the bottom of the fence.
7. Damaged support brackets and barbed wire

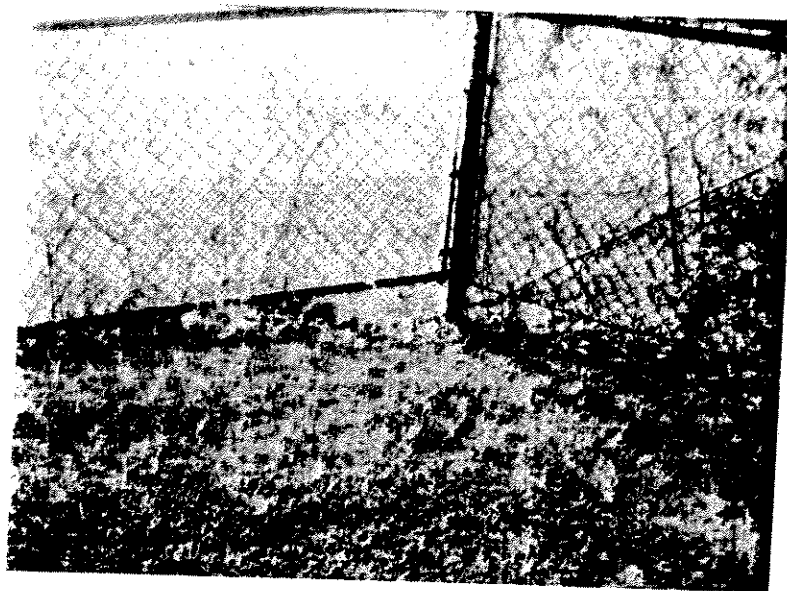
8

8. Vegetation overgrowing the fence.
9. Tree too close to the fence line.
10. Trees too close to the fence line.
11. Damaged support brackets and barbed wire.

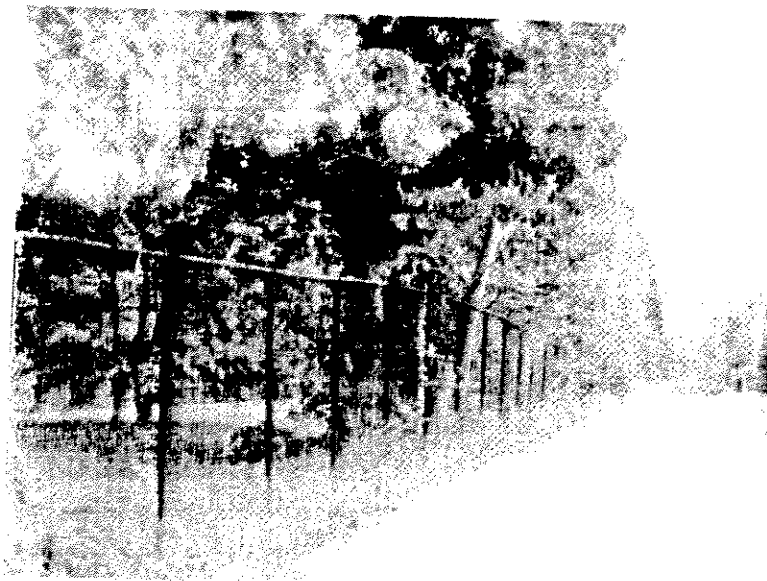
12

12. Overgrown vegetation
13. Overgrown vegetation.
14. Damaged support bracket and barbed wire.
15. Damaged support bracket.
16. Tree on fence line.
17. Overgrown vegetation.

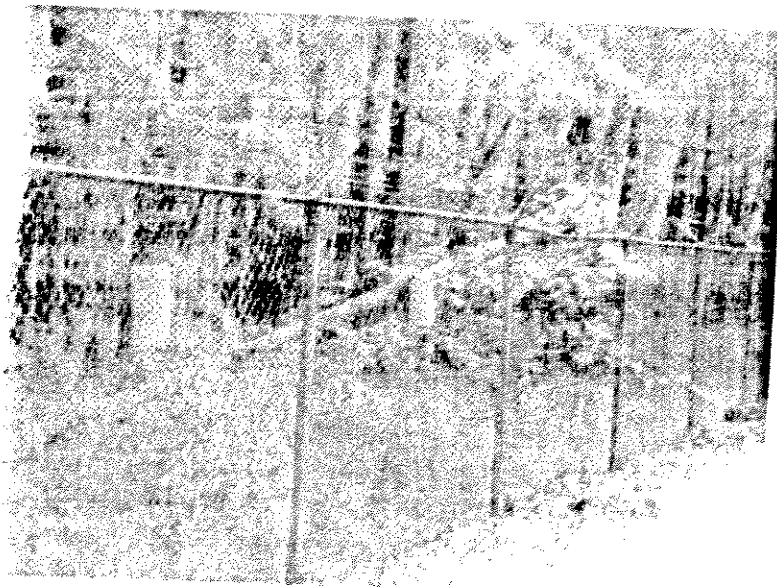
18

18. Damaged top rail, support brackets and barbed wire.
19. Approximately 8" between the ground and bottom of fence.
20. Damaged support brackets and barbed wire.

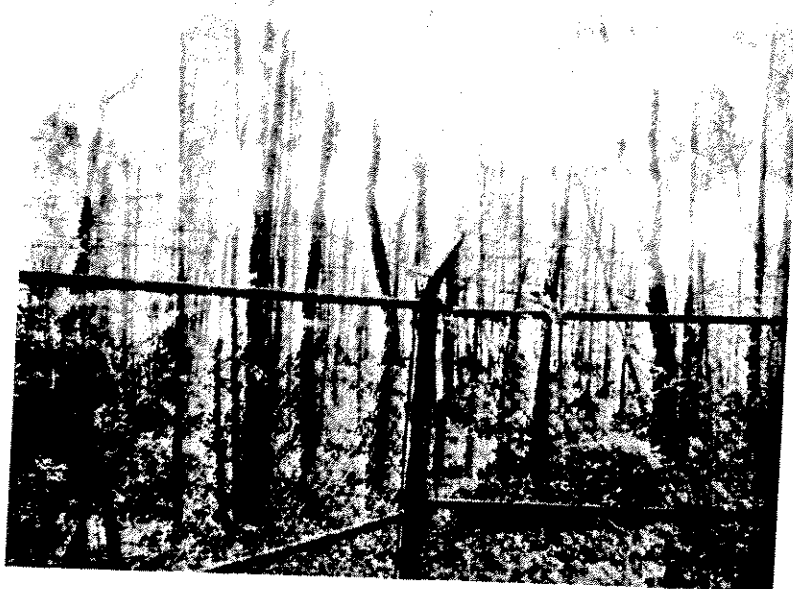
21

21. Damaged support brackets and barbed wire.
22. Damaged top rail, support brackets and barbed wire.

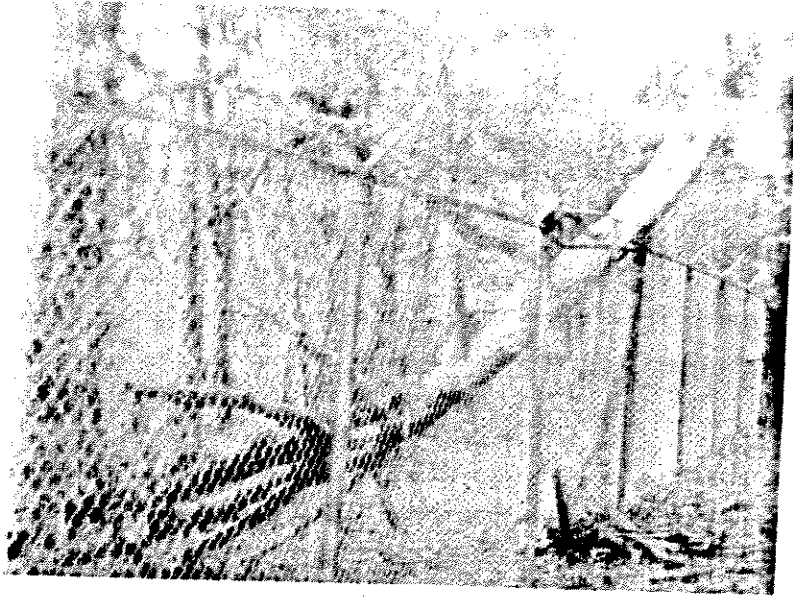
23

23. Tree on fence, damaged support brackets, barbed wire and top rail.
24. Damaged top rail and barbed wire.
25. Damaged top rail.
26. Damaged support bracket.
27. Damaged support bracket.
28. Damaged support bracket, barbed wire and top rail.
29. Damaged support brackets and top rail.
30. Damaged support brackets and top rail.
31. Damaged support brackets.

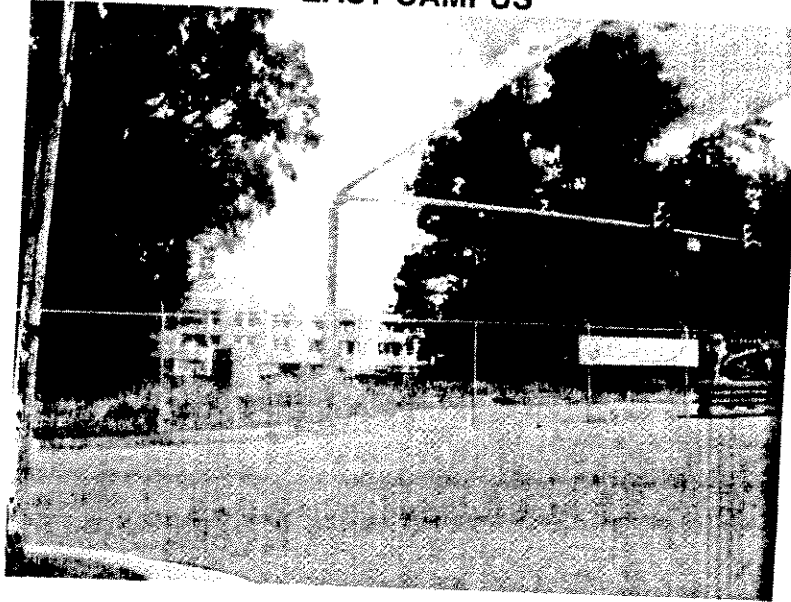
1

1. New temporary fence line and building.
2. Overgrown vegetation.
3. Support bracket missing, damaged top rail and barbed wire.

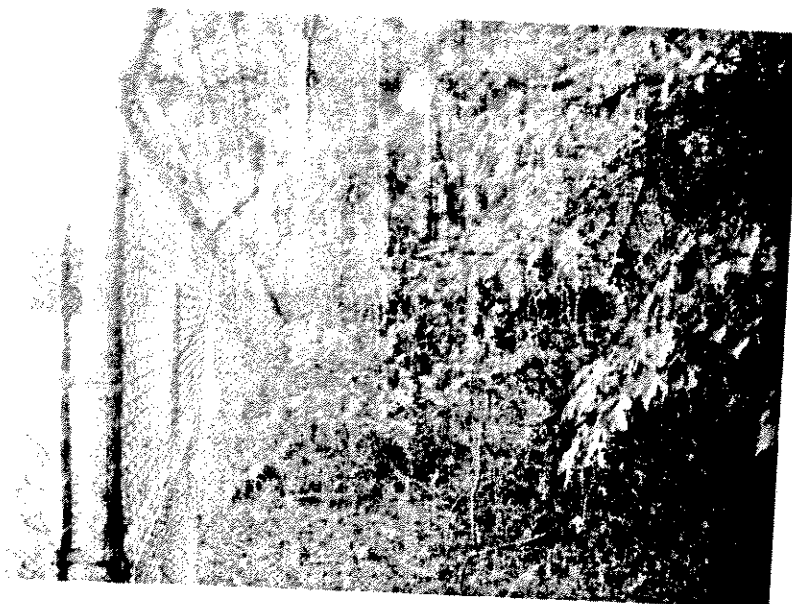
1

1. Overgrown vegetation.
2. Overgrown vegetation.
3. Overgrown vegetation.
4. Overgrown vegetation.
5. Overgrown vegetation, trees on fence, damaged top rail, support brackets, barbed wire.

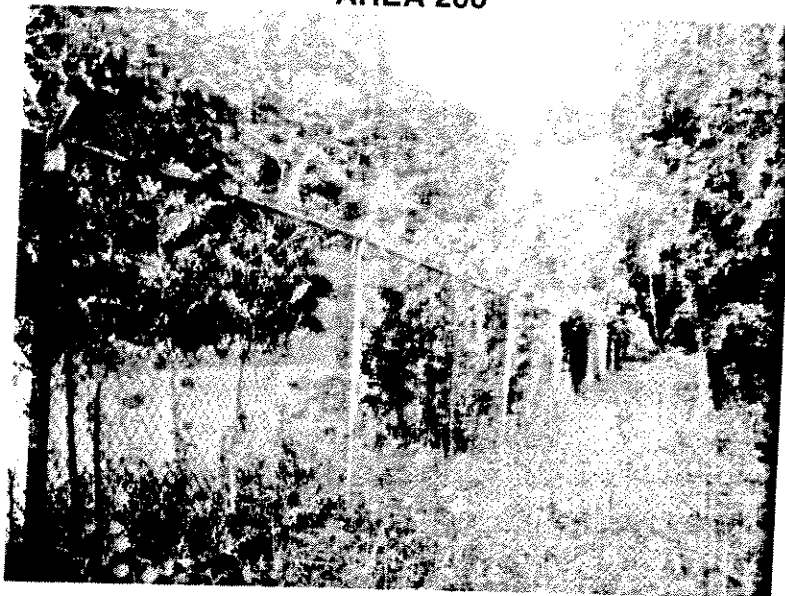
1

1. Support bracket damaged.
2. Tree on fence.
3. Damaged fence post, approximately 24" between fence and ground.
4. Tree on fence, damaged top rail and barbed wire.
5. Trees on fence, damaged top rails, support brackets and barbed wire.
6. Barbed wire damaged.
7. Trees on fence, damaged top rails, support brackets and barbed wire.
8. Damaged top rail, support brackets, fencing and barbed wire.
9. Tree on fence, damaged top rail, support bracket, and barbed wire.

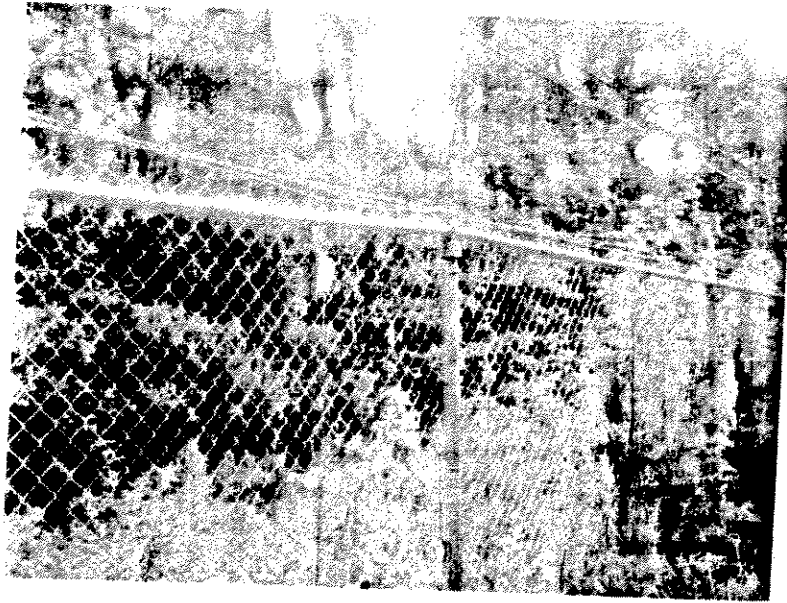
1

1. Damaged support bracket.
2. Damaged top rail, support bracket, barbed wire and fencing.
3. Damaged top rail, support bracket, barbed wire and fencing.
4. Tree on fence, damaged top rails, support brackets, fence post, barbed wire and fencing.
5. Tree on fence, damaged support brackets and top rail.
6. Damaged top rails, support brackets, barbed wire.
7. Damaged top rails, support brackets, top rail, barbed wire, fence posts and fencing.
8. Damaged top rails, support brackets, top rail, barbed wire, fence posts and fencing.

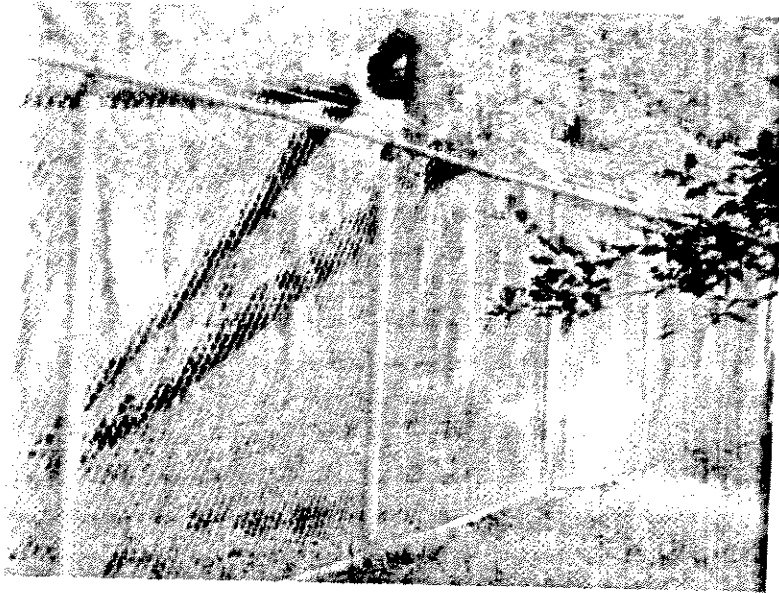
9

9. Tree on fence, damaged barbed wire.
10. Tree on fence, damaged top rail, support brackets, barbed wire and fencing.
11. Damaged top rails, support brackets, barbed wire and fencing.
12. Damaged top rails, support brackets, barbed wire, fencing and fence posts.
13. Damaged top rails and support brackets.
14. Damaged top rail, support bracket and barbed wire.
15. Damaged top rail, support bracket and barbed wire.
16. Tree on fence, damaged barbed wire.
17. Tree on fence, no damage.
